**CORROSION FATIGUE OF HIGH STRENGTH
AIRCRAFT STRUCTURAL MATERIALS —
CRYSTALLOGRAPHIC DEPENDENCE OF
FRACTURE PATH IN AL-Zn-Mg (7075) ALLOYS**

MASSACHUSETTS INSTITUTE OF TECHNOLOGY
DIVISION OF SPONSORED RESEARCH
77 MASSACHUSETTS AVENUE
CAMBRIDGE, MASSACHUSETTS 02139

DECEMBER 1977

TECHNICAL REPORT AFML-TR-77-36

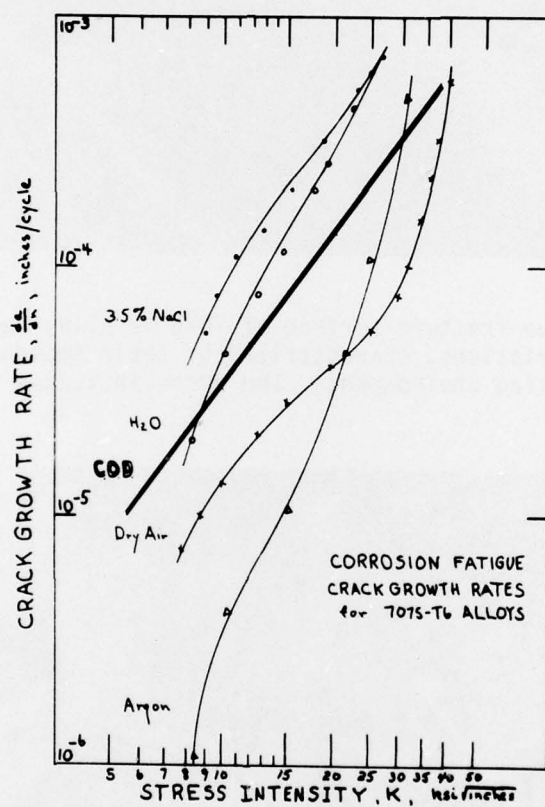
Figure 1. Corrosion fatigue crack growth rates, da/dN , vs. stress intensity factor, ΔK for a 7075-T6 alloy. Testing environments were inert argon (20 ppm water vapor), dry air (200 ppm water vapor), distilled water and 3.5% NaCl solution.

The growth rate measurements reported in Figure 1 were macroscopic rates, measured by observing a running crack in a thin plate. The microscopic growth rates are given by the striation spacings measured on the fracture surface. The striation spacing as well as the morphology of the fatigue striations are strongly dependent upon the environment. In the early 1960's, two distinct types of fatigue striations were observed and differentiated⁽¹⁾: ductile striations which form in an inert or dry environment, and brittle striations which are strongly promoted by the presence water and of halide ions. Figure 2 shows typical ductile striations which are characterized by their smooth rumpled appearance, and the uniform advance of the fracture front over the width of a single grain. The fracture process resulting in ductile striations is dominated by shear flow and blunting at the fatigue crack tip.

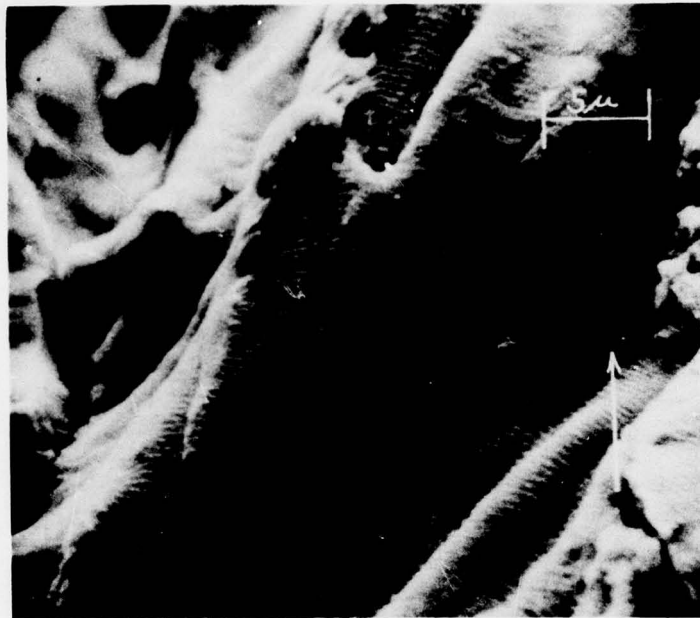
Figure 2. Fatigue fracture surface of 7075-T6 alloy tested in laboratory air. Ductile striations, characterized by their smooth fracture front, form in this testing environment. The arrow indicates the crack propagation direction.

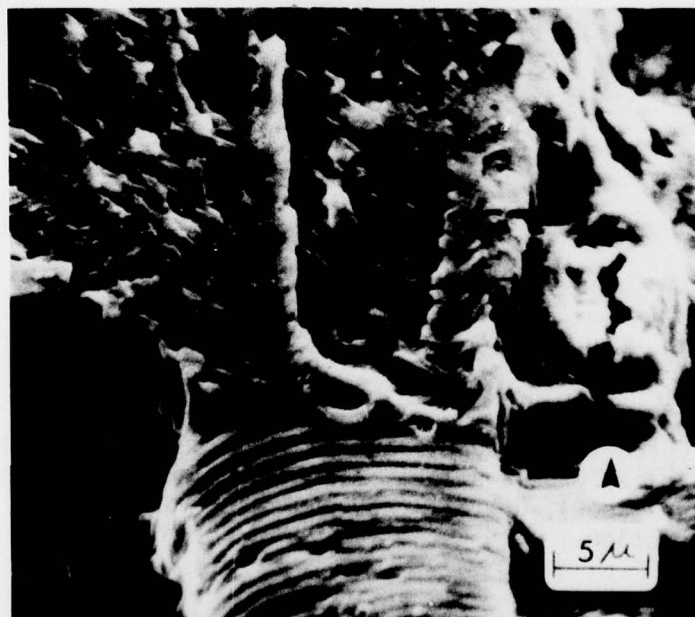
Figure 3. Abrupt transition from ductile to brittle striation morphology in 7075-T6. Fatigue testing was begun in air with a 3.5% NaCl solution added during the test. The dotted lines demarcate the brittle striation width, approximately five times larger than the ductile striation spacing.

By rapidly changing the environment one can see the strong effect this has on the fracture surface features. Figure 3 is taken from the fracture surface of a sample tested in air with a NaCl solution added without interrupting the test. The ductile striations are at the bottom of the micrograph. With the NaCl addition the striation features instantly change to a brittle morphology. The striation spacing increases approximately five-fold and river markings suggesting a cleavage fracture run perpendicular to the striation front. In Figure 4, at low magnification, the crystallographic dependence of the brittle striations can be seen. Large flat areas

Since the two types of striations are so distinct they can be used to compare the effects of various environments on the microprocesses of corrosion fatigue. The effects of a rapid change from air to chloride solution on the surface features has been shown in Figure 3. Early workers^(2,3) also found that in a chloride solution the striation morphology is strongly affected by the magnitude and the direction of an applied current. In order to exploit this behavior the following test was performed: while undergoing cyclic stresses in a 3.5% NaCl solution, a plate of 7075 was alternately polarized anodically and cathodically against a platinum counter electrode. The stress cycling rate was adjusted so as to impress a 0.5 ma anodic current for 20 stress cycles and a reverse 0.5 ma cathodic current for 10 stress cycles. The current was applied to an exposed sample area of 0.125 square inches. The rest potential of the sample was -0.820 vs. SCE. The applied current polarized the sample to a cathodic potential of -1.400V and an anodic value of -0.700V.

Additional tests have been performed in order to understand the electrochemical processes occurring under anodic polarization. Addition of a sodium nitrate inhibitor to a sodium chloride solution causes the striation morphology to revert from brittle to ductile (essentially the opposite effect of Figure 3). Testing in an anodizing solution of sodium carbonate plus sodium chromate also results in ductile striations, demonstrating that a mildly oxidizing environment at the crack tip is beneficial for corrosion fatigue.

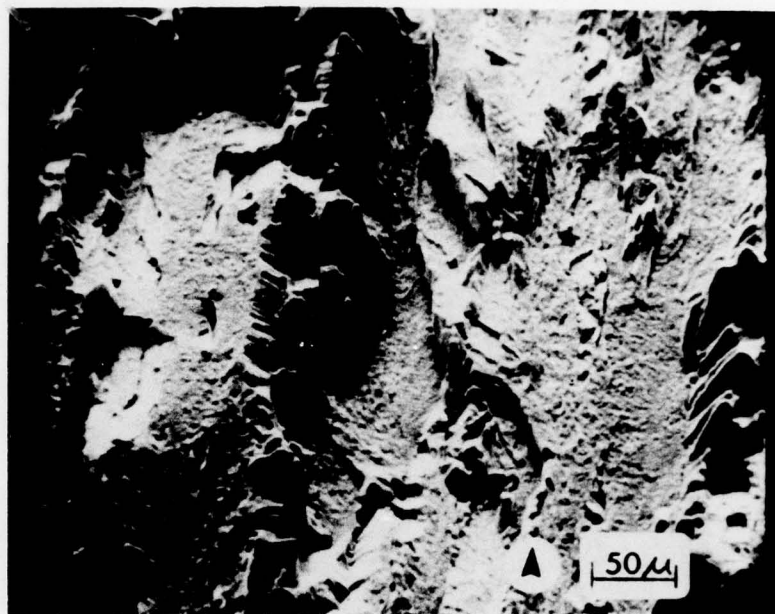
Figure 4. Low magnification micrograph of 7075-T6 tested in 3.5% NaCl solution. Fracture surface orientation changes from grain to grain, indicating a strongly crystallographic fracture mode.

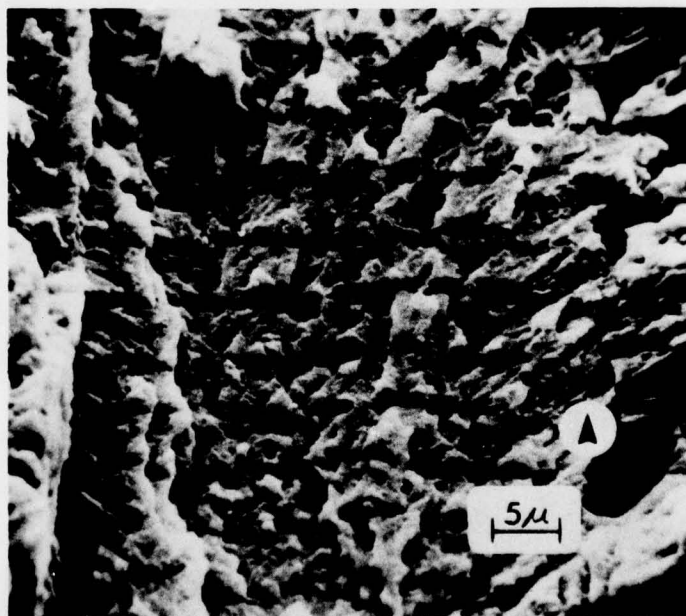
Figure 5. Brittle striations formed in 7075-T6 in a 3.5% NaCl solution. The fracture front is highly irregular, with small features extending across each striation step and river markings in the direction of crack propagation.

corresponding to the existing grain structure are sharply inclined to one another. Efforts to determine the orientation of the fracture plane, however, have not proved successful. Details of the brittle striations are shown in Figure 5. Small tongue-like features extend from one striation step to the next. The crack front is highly irregular across a single grain, indicating a local cracking and "unzipping" process across the front. Also, the fracture surface between the striations is generally very flat, further evidence of a crystallographic mode of fracture.

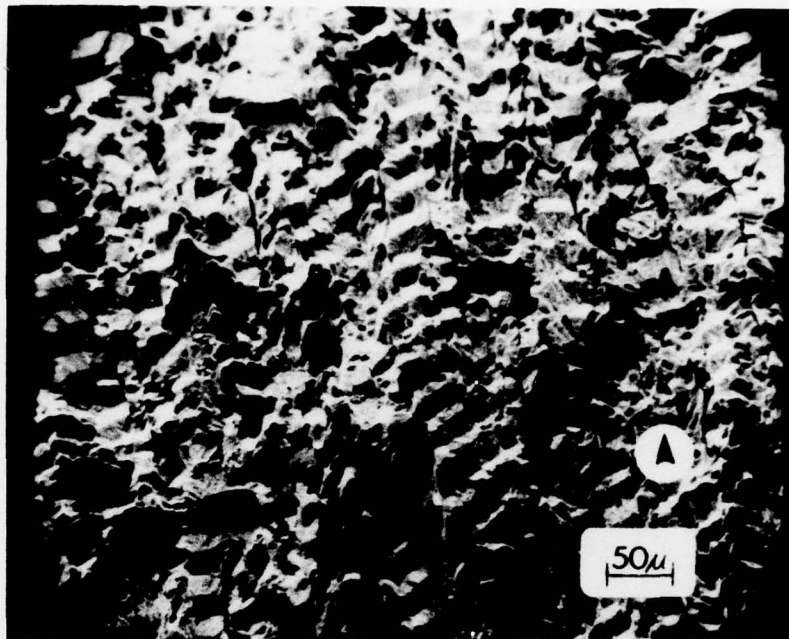
Figure 6. Fracture surface of 7075-T6 tested in a 3.5% NaCl solution with an alternating 0.5 ma anodic and cathodic current. Light and dark bands, due to fracture surface orientation differences occur in selected grains.

The fracture surface was analyzed by scanning electron microscopy and the effects of the alternating current were striking. In Figure 6, each light and dark band represents the anodic and cathodic stress cycling period. The relative contrast of each band is related to its orientation with respect to the SEM detector. The overall features depend on the grain orientation in that some grains do not contain any light and dark bands, and in some the band contrast is reversed. At higher magnifications, Figure 7, the nature of the light and dark regions becomes clear. At each current reversal the orientation of the fracture surface changes, giving a "stair-step" fracture surface. In some grains the detail of the plateaus can be seen (Figure 8). Twenty ductile striations and ten brittle striations can be counted, indicating that a small shift in corrosion potential anodically, from -0.820 to -0.700 can markedly change the fracture mode. It was surprising to observe that the ductile striations occur under a cathodic potential of -1.400V. It was expected that a cathodic potential would minimize the corrosion fatigue affect, but the reverse is true in this alloy. Additional features can be seen at still higher magnification (Figures 9 and 10). The transition from ductile to brittle is very smooth while that from brittle to ductile is very irregular, confirming our earlier observation on the nature of the crack front advance in both cases. With proper orientation of the specimen in the SEM (Figure 11), the true striation spacing can be measured. The ductile striations are approximately half as large as the brittle, giving a two-fold reduction in the local growth rate under anodic conditions. Tilting experiments indicate that the angle between brittle and ductile regions is approximately 160° for the grain shown in Figure 8. It appears

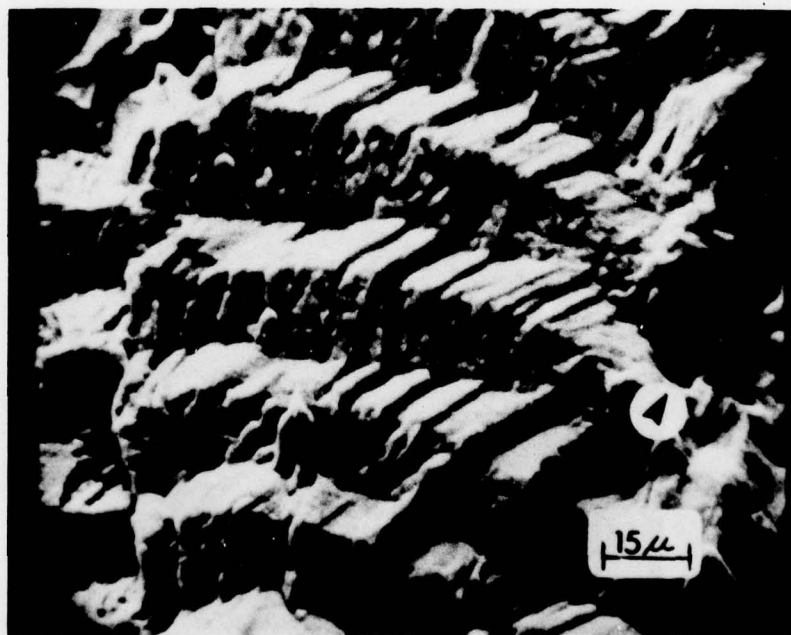
Figure 7. "Stair-step" nature of fracture surface in 7075-T6 due to anodic-cathodic current reversals.

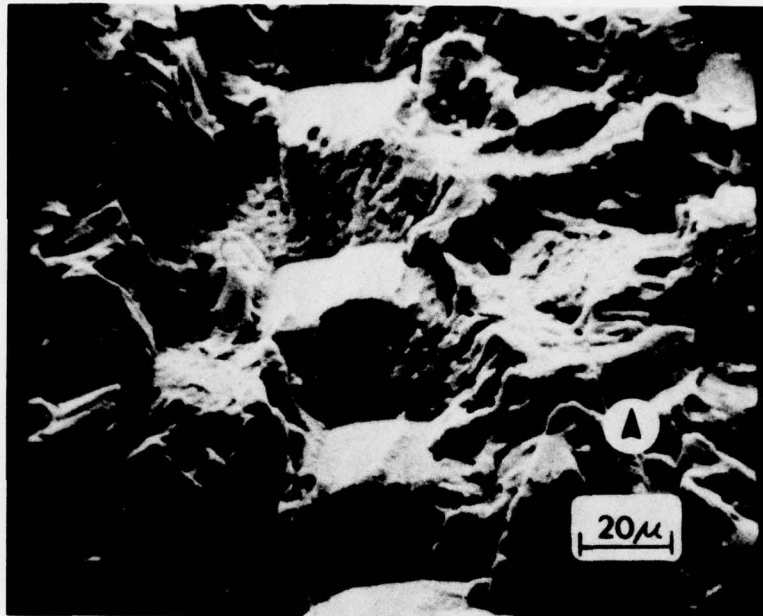
Figure 8. Details of fracture surface plateaus in 7075-T6 tested under alternating current condition. Twenty ductile striations form under an anodic potential of -0.700V vs. SCE while ten brittle striations form at -1.400V cathodic. The contrast effects indicate a sharp change in fracture surface orientation at each current reversal.

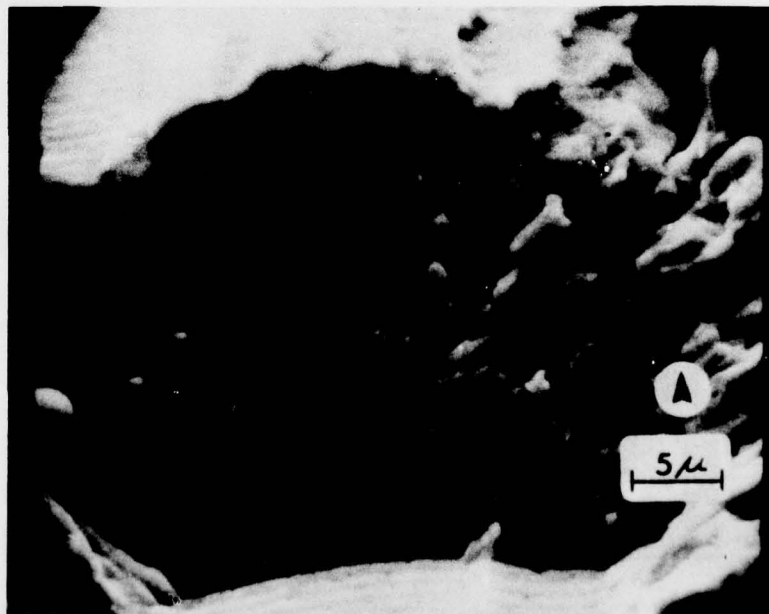
Figure 9. High magnification micrograph of Figure 8. Ten brittle striations are shown, corresponding to the ten stress cycles applied under -1.400V cathodic conditions.

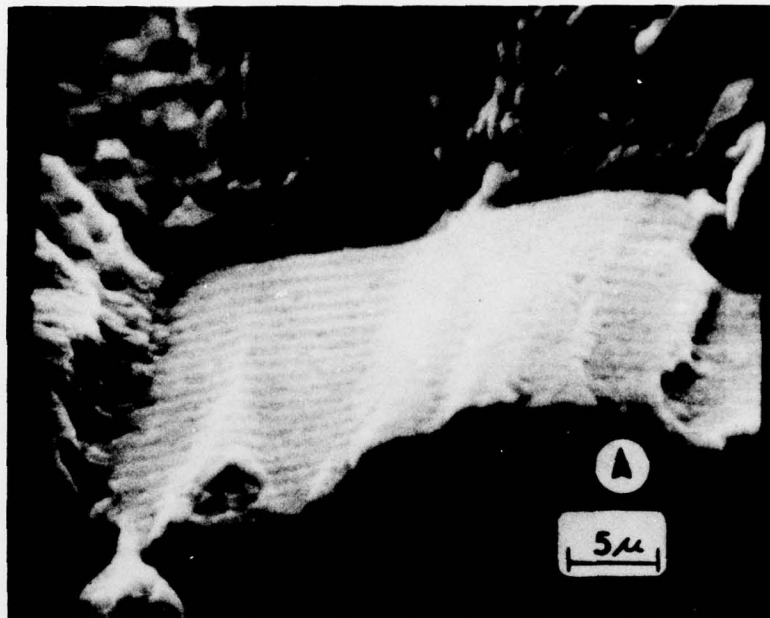
Figure 10. High magnification micrograph of Figure 8. Twenty ductile striations are shown, corresponding to the twenty stress cycles applied under $-0.700V$ anodic conditions.

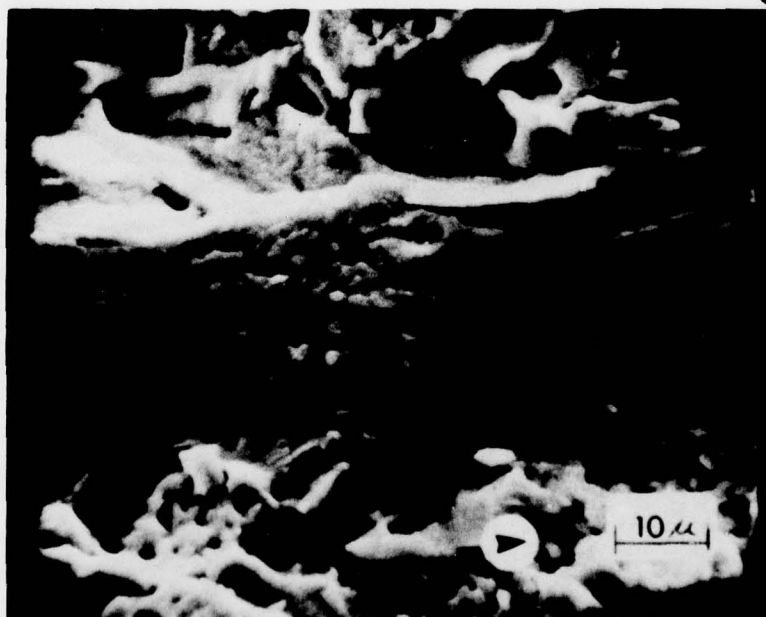
Figure 11. Micrograph of the same region as Figure 8, with fracture surface oriented at zero degree tilt with respect to the SEM collector. True striation spacing measurements indicate the spacing is twice as large under cathodic conditions (brittle) as under anodic conditions (ductile).
